Investigation of Otto Fuel Explosion Accident

Wilfred Baker Engineering, Inc.

August 20, 1996

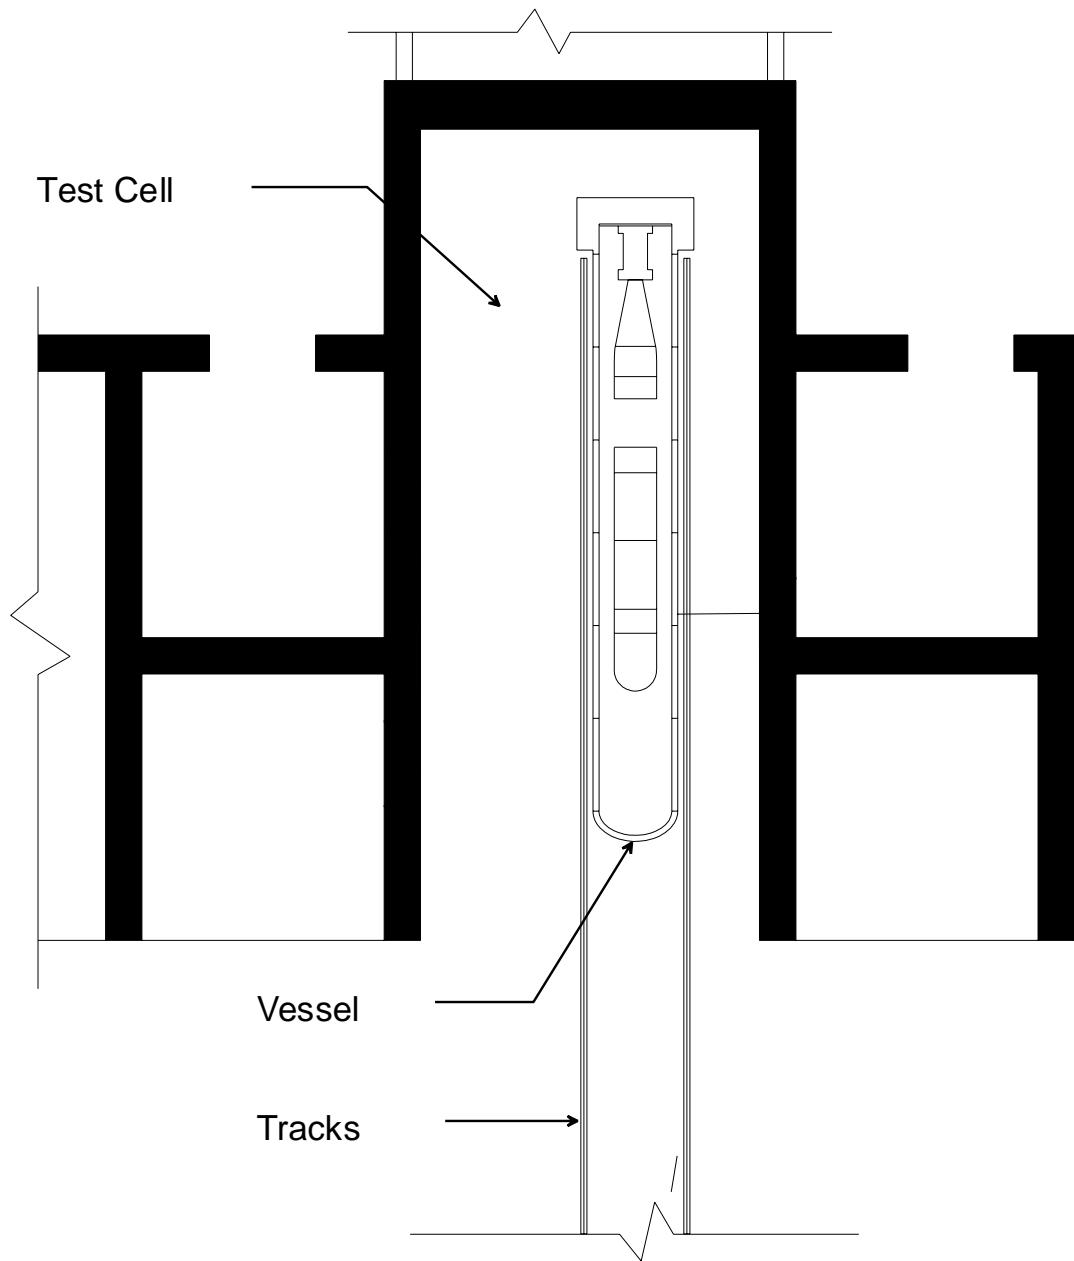
Figure 1. Floor Plan of Test Cell

The main test cell of Building 179 was constructed of 18 inch thick reinforced concrete walls and roof. Plan dimensions for the cell were 14 ft wide and 34 ft long with a height of 14 ft as shown in Figure 1. This cell was bordered by smaller test cells on two sides. One wall of the structure was designed to vent an explosion and was constructed of angle framing with fiberglass panels.

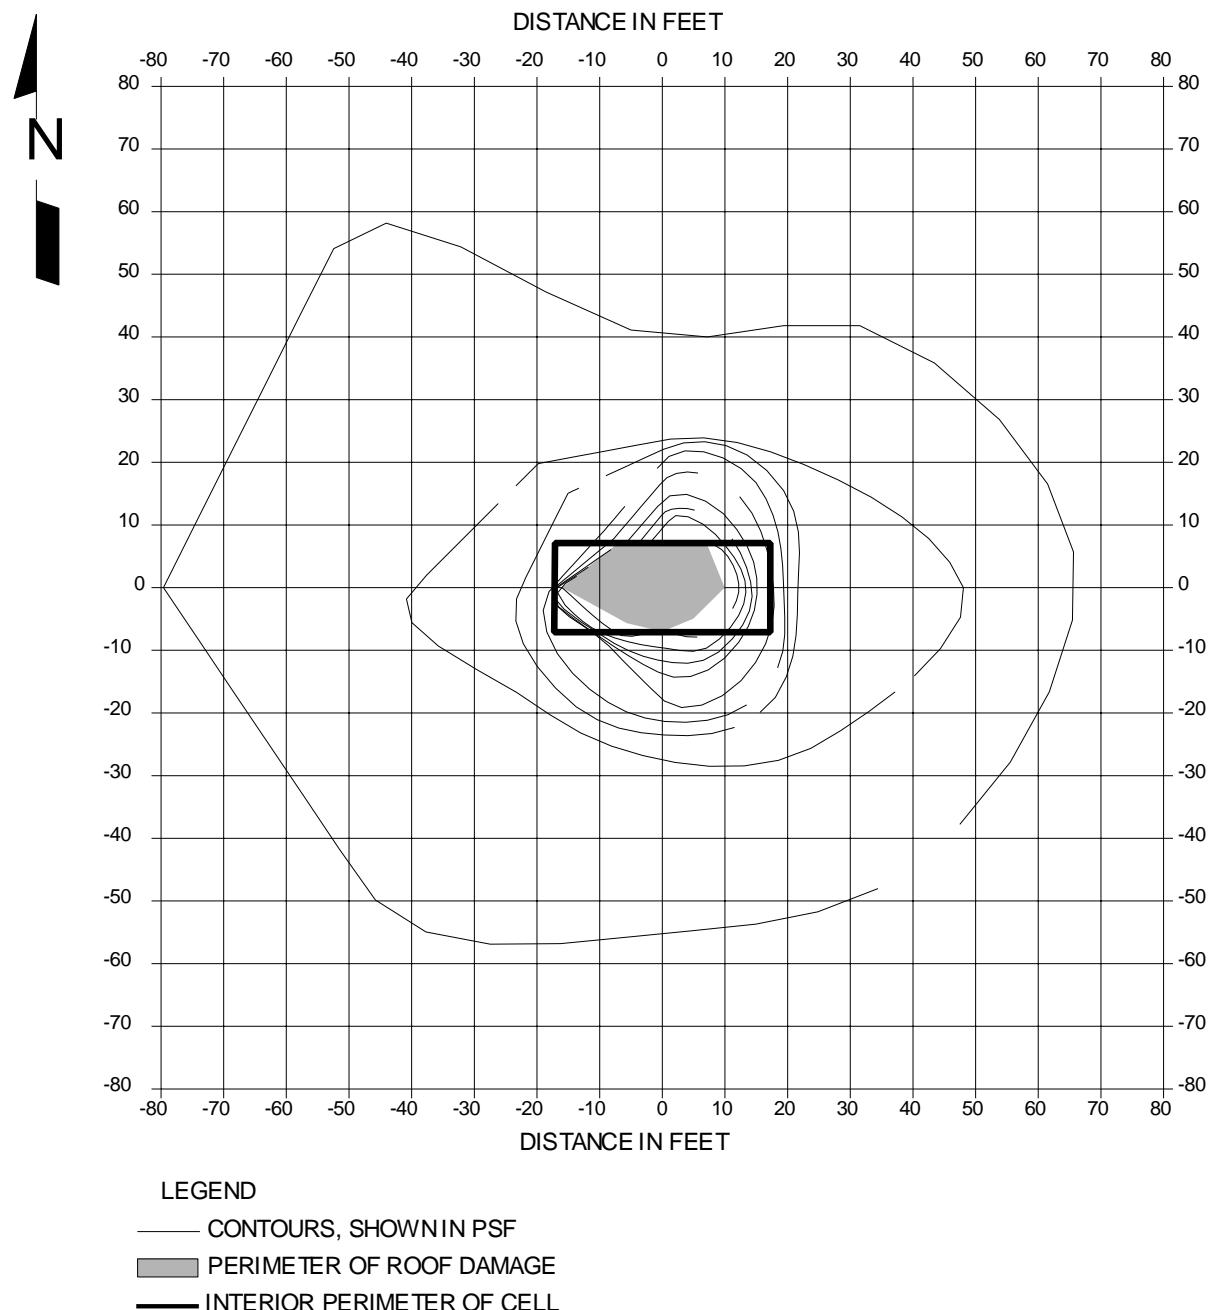
Figure 2. Concrete Debris

Damage to the test cell was substantial. Detonation or decomposition of the monopropellant, Otto fuel, created a shock wave which destroyed the 3 inch thick, water-filled containment pressure vessel. Fragments from the vessel traveled radially from the centerline and impacted the north and south walls, roof slab, and floor. The most extensive damage occurred in the roof where approximately 85% of the roof slab was removed. The post accident condition of the roof indicated that reinforcing bars in the roof slab did not develop sufficient anchorage to rupture the reinforcing. Instead, splices located near the edge of the roof slab separated and released large sections of the slab. Vessel fragment impacts on the concrete caused the walls and roof to break into numerous pieces. Most of the concrete debris from the roof fell back into the cell with portions deposited on the roof around the perimeter of the hole. A small percentage of the concrete debris was distributed to the north and the south of the bay out to a distance of about 60 ft. The floor slab was damaged over approximately 40% of the surface with some damage extending near mid-depth. Damage to the cell and distribution of concrete fragments is shown in Figure 2.

The concrete debris was collectively weighed in each fragment collection grid area in order to produce a contour map of the concrete debris distribution. Concrete debris which remained inside the test cell or any adjacent cell could have originated from the damaged walls and were not weighed or included in the concrete distribution contour map. The weight of concrete from each grid area was converted to a density value of pounds per square foot which was then plotted by distance and direction from the center of the test cell and contour lines were drawn. This was done to determine the distribution of concrete debris from the damaged roof and allow computation of probable initial velocities for the debris.

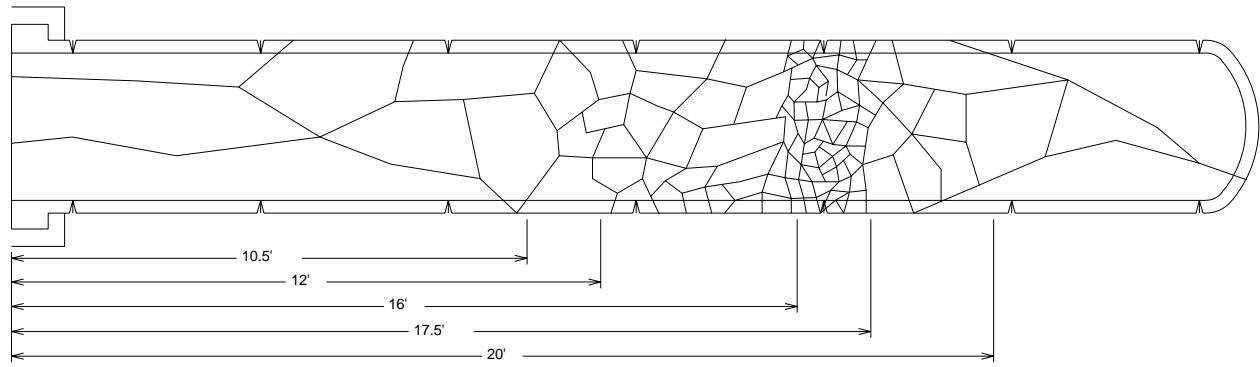
Figure 3. Pressure Vessel Fragmentation

The fragment size varied considerably along the length of the vessel as depicted in Figure 3. The smallest fragments were located in a band that began about 16 ft forward of the rear flange and terminated at about 17.5 ft as mentioned above. The fragments were consistently of a small size and were randomly spaced around the circumference. Forward and aft of this section, fragment sizes became noticeably larger. There was a band from about 12 ft to about 16 ft forward of the flange where the fragments were “medium” size. The smallest fragments in this zone were located under each of the two tracks at the bottom of the vessel, with a few larger fragments between the tracks. The largest fragments were located at the top of the vessel.

Aft of the zone, the fragment sizes became very large. The largest single fragment was from the top of the vessel and measured 10.5 ft from the flange to the forward tip. At the flange, it comprised approximately half the vessel circumference.

It was concluded from the pressure vessel reconstruction that the explosion was centered in the band of small fragments that was located from 16 to 17.5 ft forward of the rear flange. Given the uniformity of the size of the small fragments around the circumference of the vessel within this band, it was further concluded that the explosion occurred along the centerline of the vessel. The rather significant increase in fragment size either side of the band of small fragments indicates that the preponderance of the explosion energy was released within this band. This did not preclude a small explosion occurring in another part of the vessel before the vessel failed, but it did indicate that the main explosion occurred within the band described above.

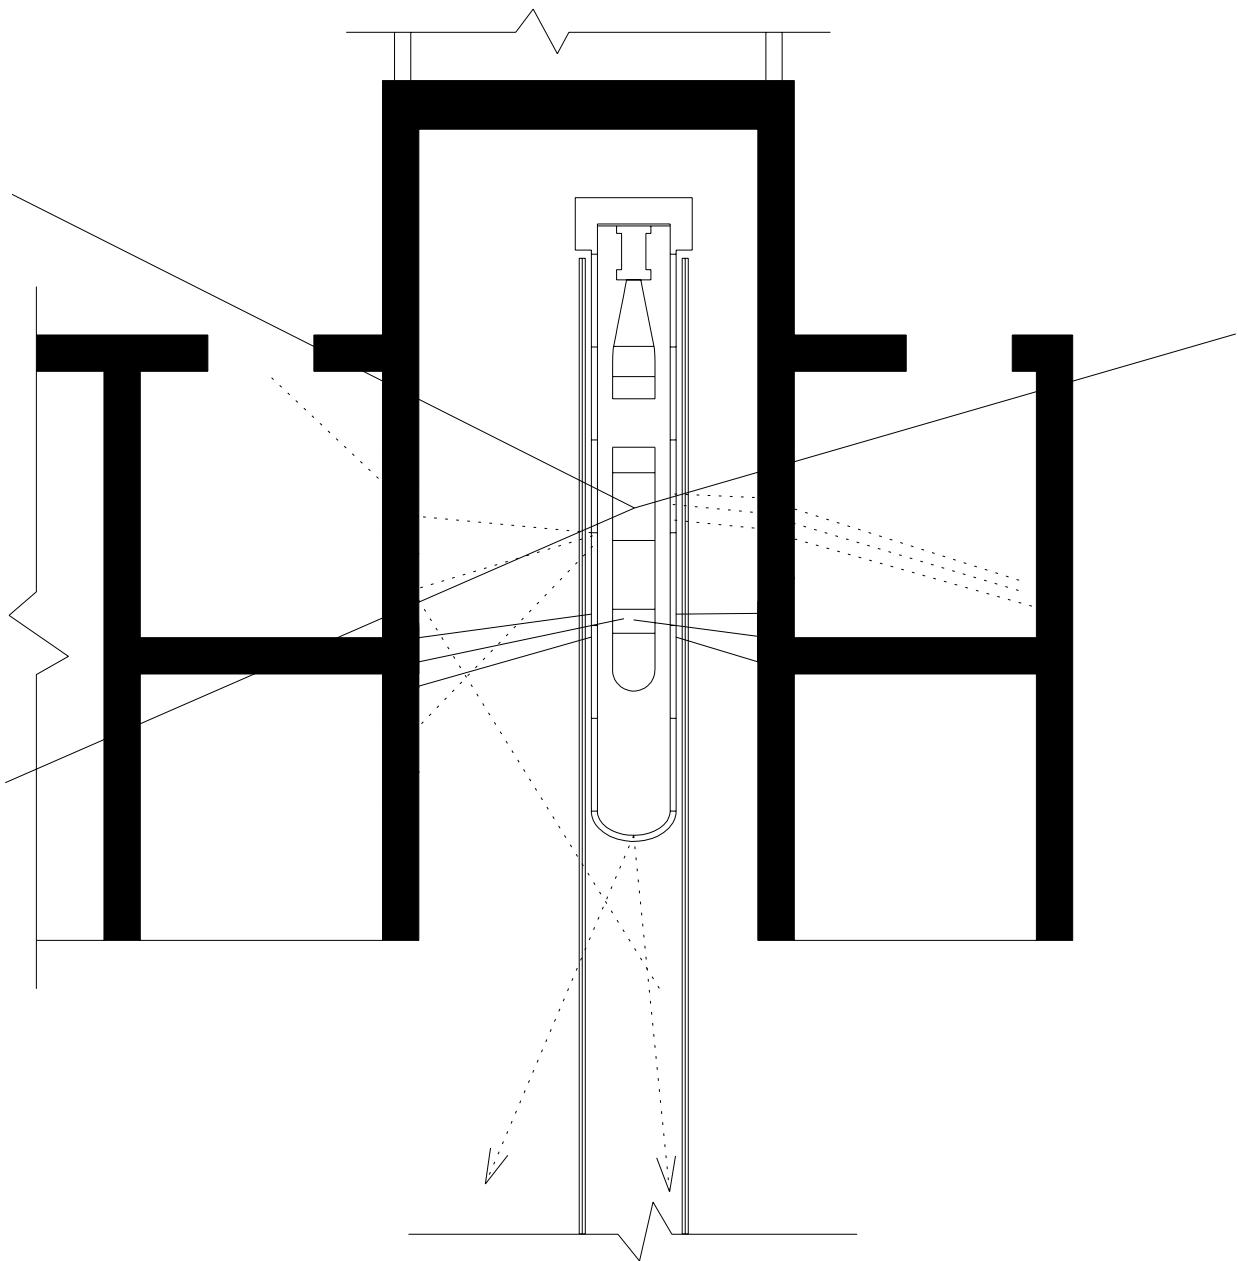
Figure 4. Vessel Fragment Trajectories

Several vessel fragments were traced along the path they followed from the original position to their final resting place after the explosion as shown in Figure 4. The paths followed by the fragments indicate the general direction most vessel fragments traveled after the explosion. The fragments used for this exercise were first located in the reconstructed vessel layout and a path was plotted to the location they were found. A few fragments penetrated the cell walls and were found in adjacent test cells. The paths for these fragments were plotted to the holes in the walls and then to the location where they were found, creating a deflected path for a few of the fragments. One fragment used in this analysis was found on the opposite side of the test cell from its original position indicating a ricochet. One of the larger impact locations on the south wall of the test cell was used in determining its path.
